Dr. Julian Osorio, DDS
Private Practice Boston, MA, and Exeter, NH, USA
Faculty, Graduate and Post Graduate Prosthodontics
Tufts University School of Dental Medicine

Precise and reliable abutment placement for longterm esthetic results

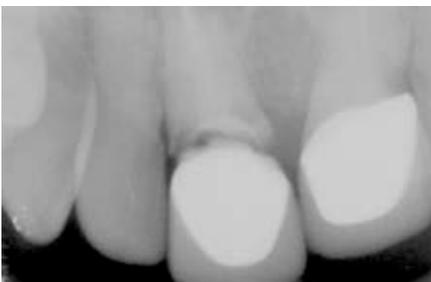
1. Radiological pretreatment situation. Horizontal tooth fracture on tooth 11 below tissue level.

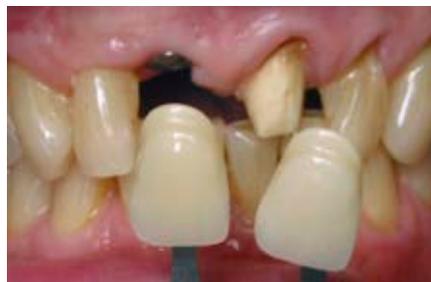
2. The tooth was extracted, and after healing, an OsseoSpeed TX 3.5 S x 11 mm implant was placed with a healing abutment. Final impression was taken and shade determined.

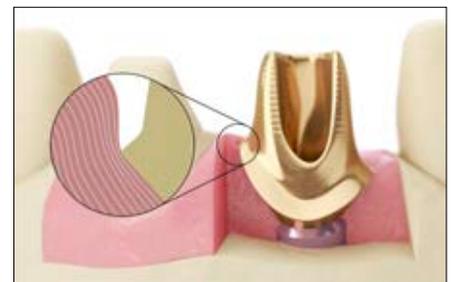
3. "Contour tissue" was the preferred emergence width option and selected in Atlantis WebOrder. The restorative margin was defined to be slightly subgingival. The image is used for communication purpose.

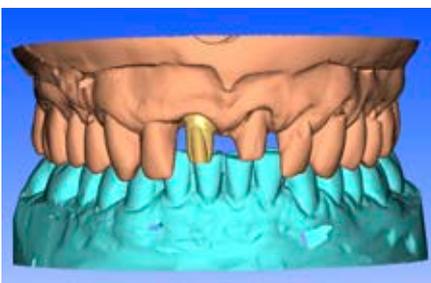
4. The shape and form of the abutment was created using the proprietary Virtual Atlantis Design (VAD) software technology, which takes the specific edentulous space, surrounding teeth, and soft tissue anatomy into consideration.

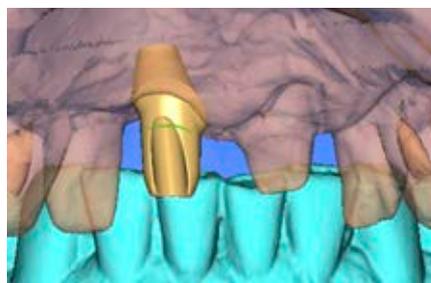
5. The Atlantis Abutment was designed to support the soft tissue. The position of the margin was placed, allowing for easy removal of excess cement during cementation.

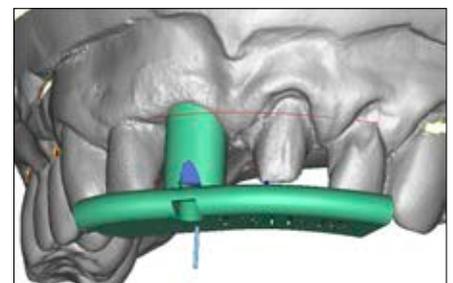
6. An Atlantis Abutment Insertion Guide was created based on the Atlantis Abutment design file. The insertion guide uses adjacent teeth as an index and it accurately matches the abutment margin.

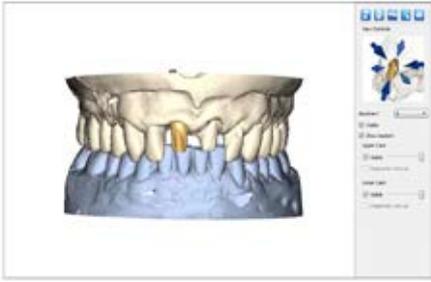
7. The design of the abutment was reviewed and edited in Atlantis 3D Editor before the Atlantis Abutment and Atlantis Abutment Insertion Guide was approved for manufacturing.

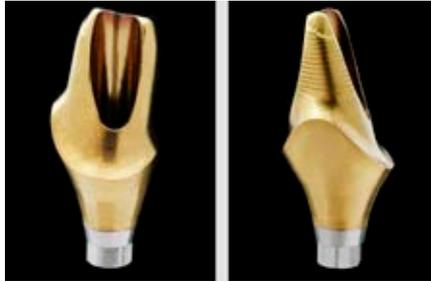
8. The Atlantis Abutment was designed to meet the patient-specific requirements and customer preferences. Gold-shaded titanium was selected as the material to support an esthetic outcome of the final restoration.

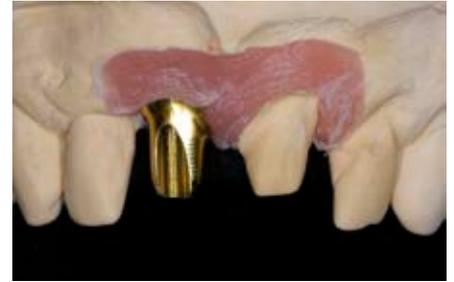
9. The Atlantis Abutment was delivered to the dental laboratory and tried out on the master model.

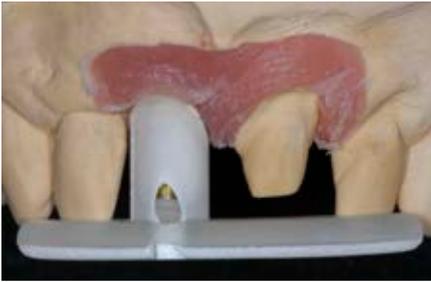
10. Try-out of the Atlantis Abutment Insertion Guide on the master model. The insertion guide was used to securely hold the Atlantis Abutment at the correct angle and orientation during installation and torquing.

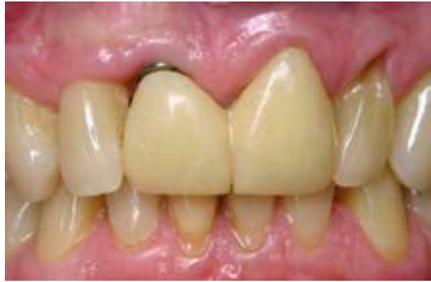
11. When the patient returned to the clinic for placement of the patient-specific abutment, the metal reinforced acrylic temporary restoration supported on tooth 21 with a cantilever on 11 was removed.

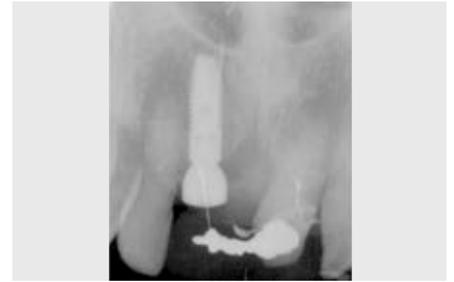
12. X-ray of the implant and healing abutment as well as the metal reinforced framework.

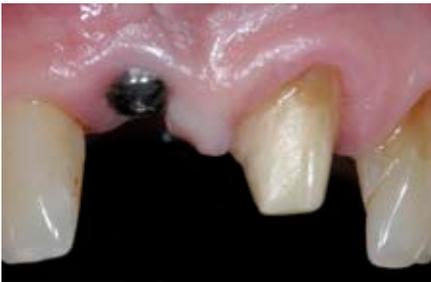
13. Removal of the temporary restoration revealed healthy marginal gingiva around the healing abutment and the adjacent tooth 21.

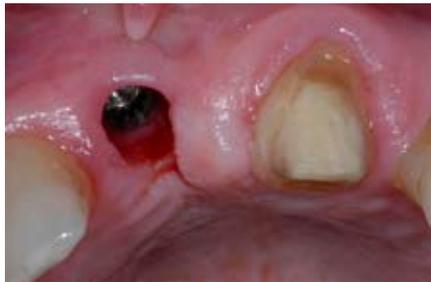
14. Due to a solid connection and no movement of the abutment, the epithelial layer was affected when removing the healing abutment and a small amount of bleeding was seen.

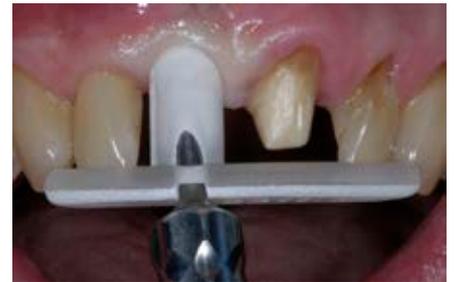
15. The abutment was placed in the guide before installation to ensure proper seating. The Atlantis abutment screw was tightened with light finger force and finally torqued to 20 Ncm.

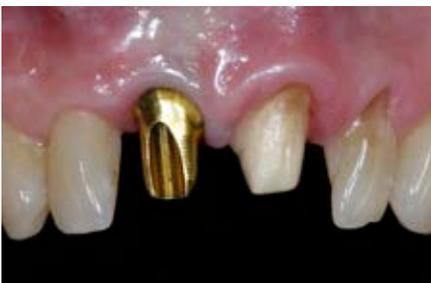
16. The Atlantis Abutment secured to the implant. The screw access hole was blocked and the case was ready for crown cementation.

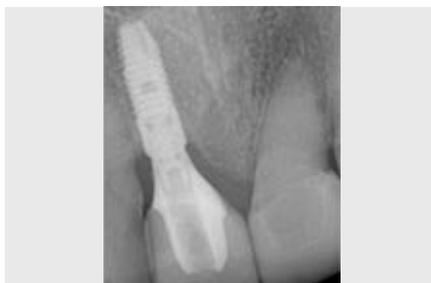
17. X-ray of the implant – the Atlantis Abutment and the final crown.

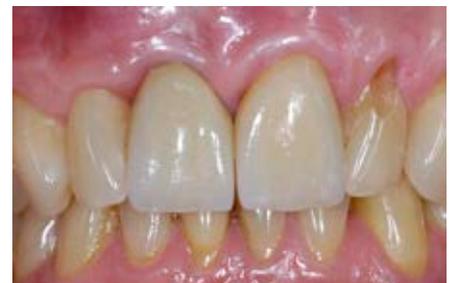
18. The final patient-specific implant restoration at position 11 and final crown restoration cemented onto prepared tooth 21.
