### Screw-retained restoration of upper right first molar and second premolar supported by the DS OmniTaper Implant System

This 64-year-old female patient has a heavily restored dentition. She has recently lost the upper right first molar and second premolar, leaving an unbounded edentulous area. An implant solution was provided using two individual screw-retained crowns supported by two OmniTaper EV implants and using a digital workflow with PrimeScan and Atlantis.

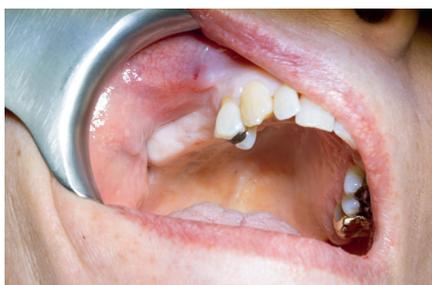
**1.** The failing upper right second premolar and first molar were extracted by the patient's general dental practitioner prior to the planned implant treatment.

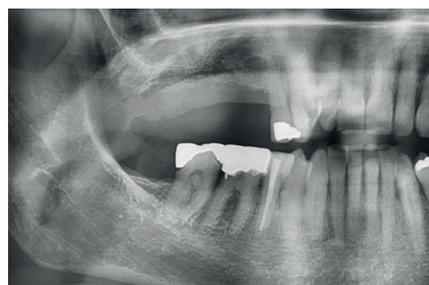
**2.** Radiographic assessment indicated that there was ample bone depth in the posterior maxilla to allow for satisfactory implant placement.

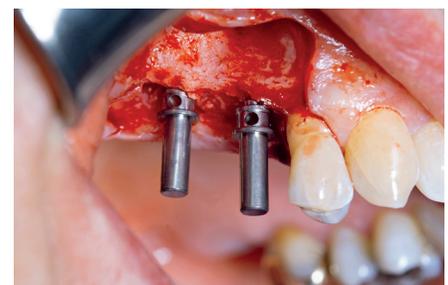
**3.** Full thickness envelope flap and Direction Indicators after initial preparation with OmniTaper Drill Ø2.0.

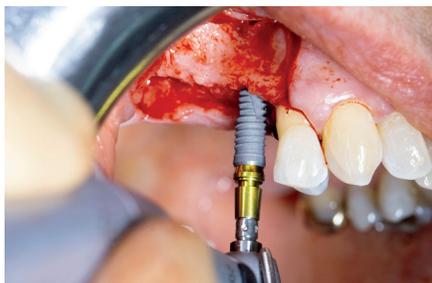
**4.** Installation of an OmniTaper EV Ø3.8 x 11 mm implant in tooth #4 (FDI 15) position using the TempBase Driver.

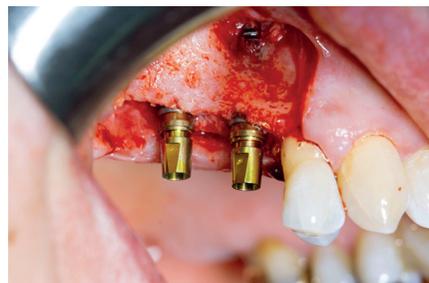
**5.** Both OmniTaper EV implants placed with the help of the pre-assembled TempBase abutments nicely aligned in tooth #4 (FDI 15) and #3 (FDI 16) positions. The implant-abutment connection size is medium (M), indicated by yellow color.

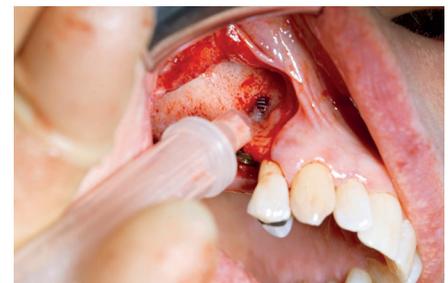
**6.** Use of Dentsply Sirona disposable BoneTrap to augment the small bone fenestration.

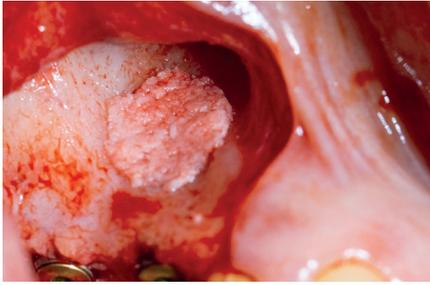
7. Large quantity of autogenous bone collected from the BoneTrap.

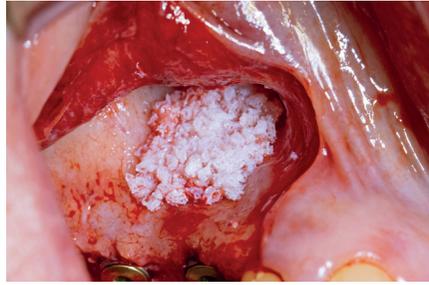
8. Symbios Xenograft Granules layered over the autogenous bone.

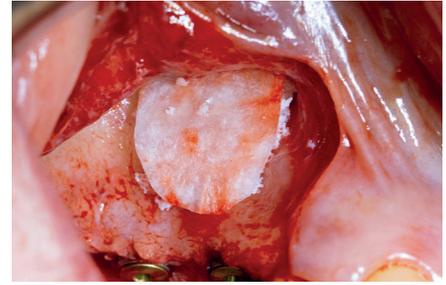
9. Symbios collagen membrane SR 15 x 20 trimmed to shape to complete the guided bone regeneration procedure.

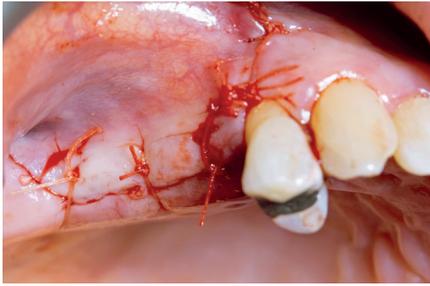
10. Passive primary closure with PGA sutures.

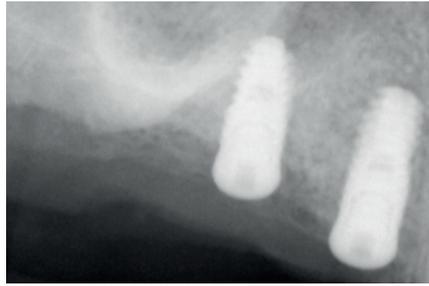
11. Radiograph of implants post-operatively.

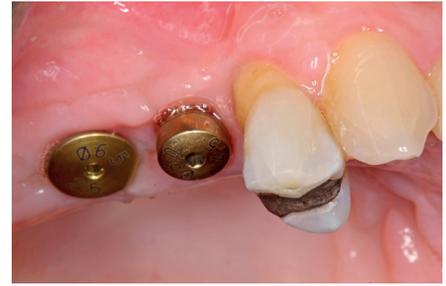
12. Healing Abutment EV (M) placed at 3 months after initial surgery.

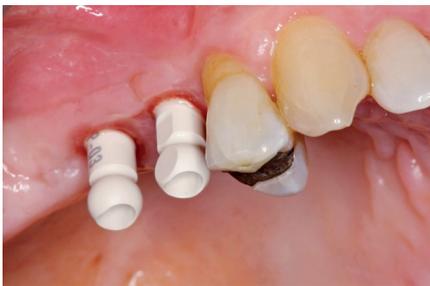
13. Atlantis IO FLO in situ ready for Primescan digital impression.

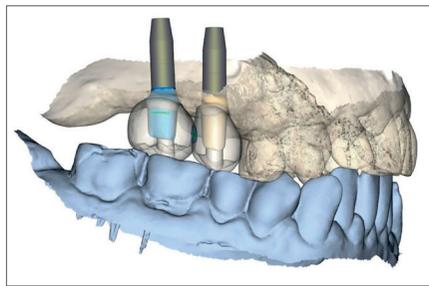
14. Design of Atlantis abutments and zirconia crowns.

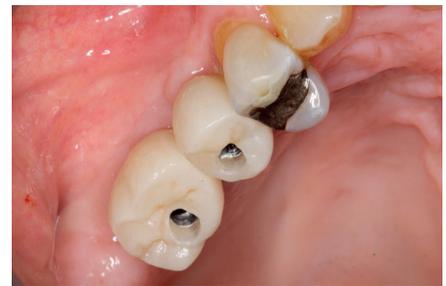
15. Well fitting screw-retained Atlantis CustomBase abutments and zirconia crowns tried in - no adjustments needed.

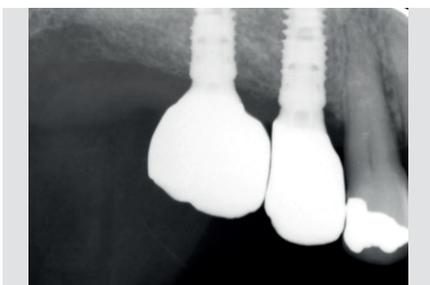
16. Radiograph to verify correct seating of restorations.

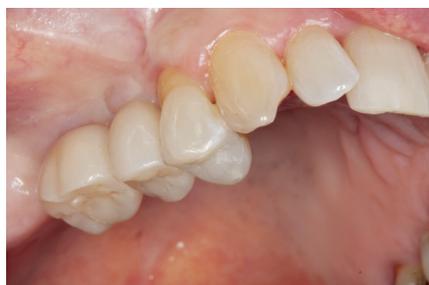
17. Screw-access channels sealed and amalgam tooth position #5 (FDI 14) replaced with composite.

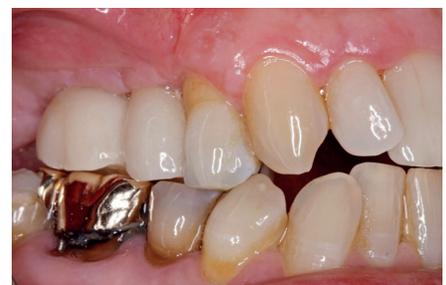
18. Final restorations completed.
