CEREC Tessera Advanced Lithium Disilicate chairside partial crown CAD/CAM restoration.

Carlos Eduardo Sabrosa Rio de Janeiro. Brazil

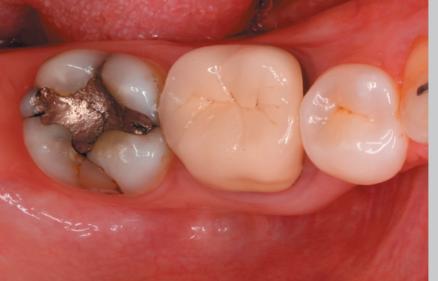
Before:

Failed amalgam restoration needing replacement. Patient complaining of sensitivity and tooth presenting multiple cracks.

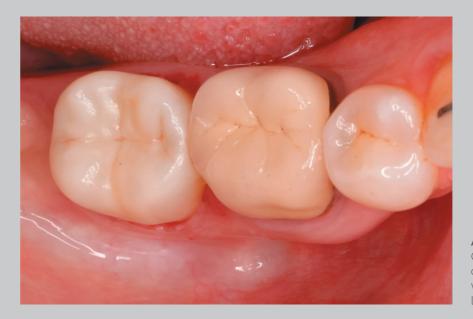
Chairside CAD/CAM partial crown restoration fabricated with CEREC Tessera Advanced Lithium-Disilicate glass ceramic.
